## Rockfall in Schöllenen

### Continuous measurement monitoring of a rockfall area

📍 Göschenen, Switzerland  
 👤 Federal Roads Office ASTRA  
 🕒 2015

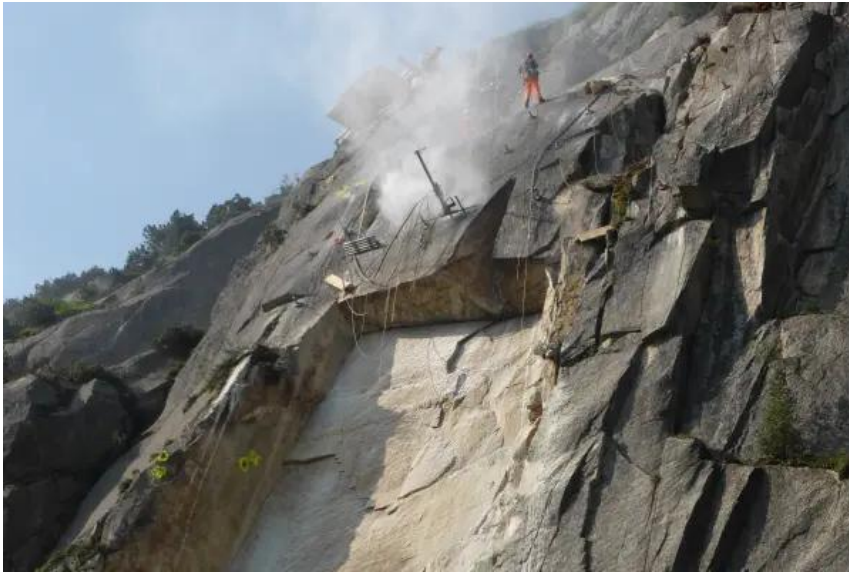
On May 20, 2015, a large rockfall occurred in the Schöllenen Gorge between Göschenen and Andermatt in the area of a road gallery, forcing the road through the gorge to be closed for safety reasons.

Above the road, 900 cubic meters of rock had broken away and partially damaged the road gallery. A further 200 cubic meters of rock threatened to break away, endangering the clean-up and rock stabilization measures.

In collaboration with Acht Grad Ost AG, Terradata was able to install two autonomous total stations in the rockfall area within a very short time and monitor the rock sections at risk of falling using measurement technology. This enabled the workers involved in securing the rock face to be warned of even the slightest movements.
