# New construction of the Lettenmatt development, Birmensdorf

Automatic evidence preservation and monitoring measurements

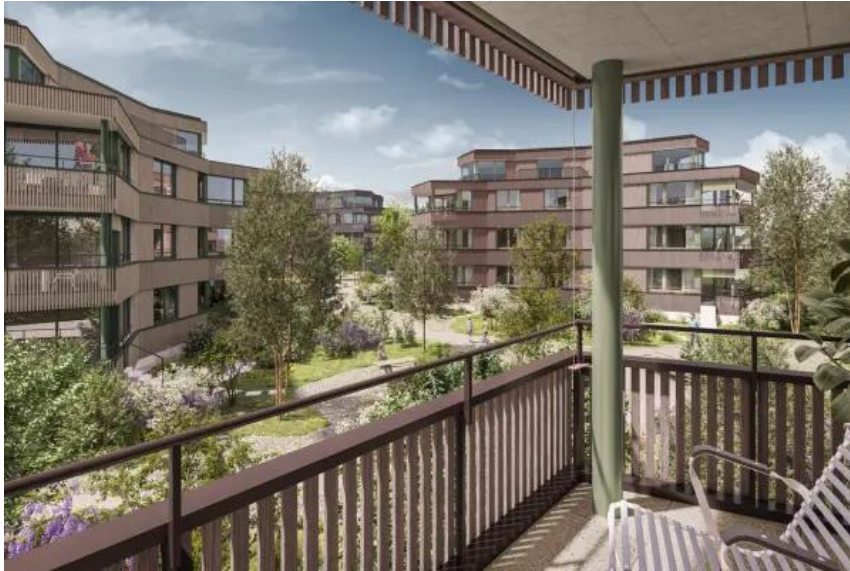
The overall project consists of eight buildings connected by a shared underground car park. A closed sheet pile box with a depth of 3 m was constructed for the building.

The construction project was accompanied by various measurement services. The sheet pile wall was monitored using automatic and manual deformation measurements. In addition, a total of 10 inclinometer measuring points were automatically monitored in two stages. Automated vibration measurements were also carried out in the surrounding area and groundwater level measurements were taken in the excavation pit.
